**KOOTENAI DEVELOPMENT IMPOUNDMENT DAM
NOVEMBER 9TH, 2007 ROUTINE INSPECTION REPORT**

BILLMAYER & HAFFERMAN ENGINEERING INC.

February 22, 2008

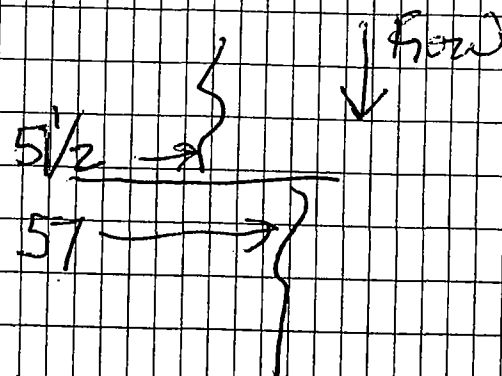
Crack displaced 1/8

@ 2nd transverse joint
Crack displaced

2/32

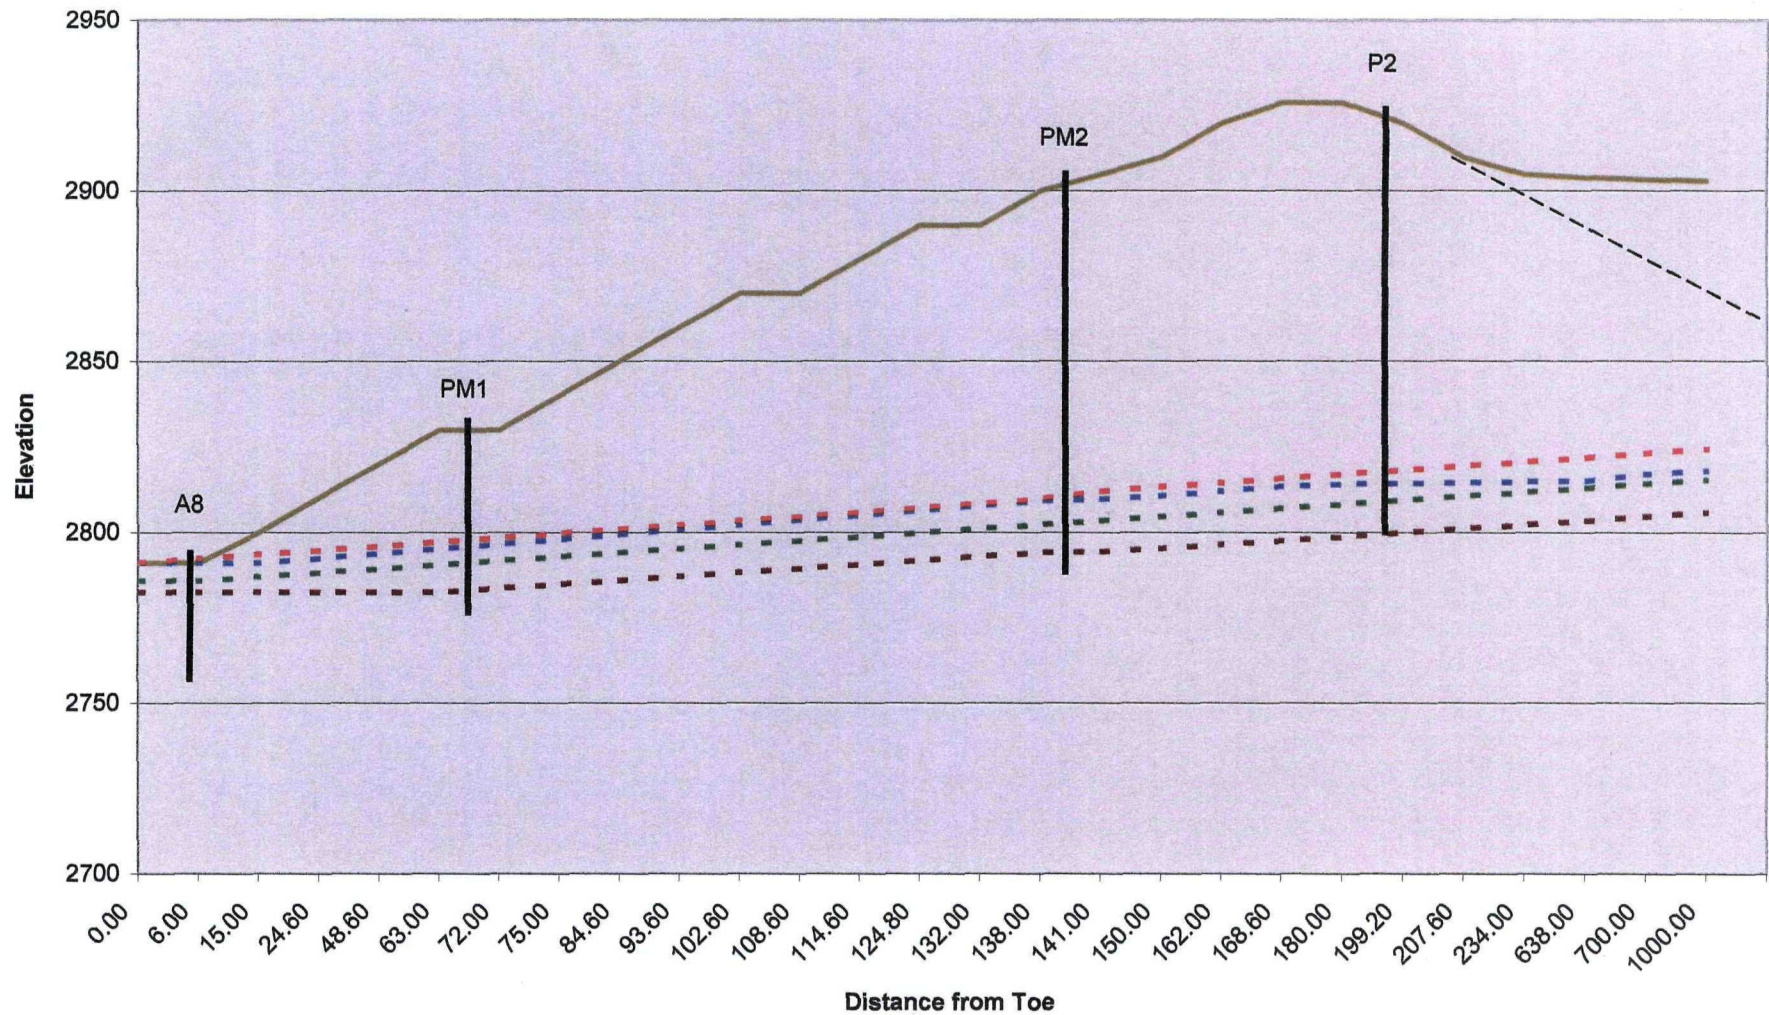
Kootenai Impoundment Dam Phreatic Water Surface Plot

All piezometers were located and a reading was obtained from each one except P-O. Piezometers P, P1, P3, PM4, PM5, and PM6 were noted as dry. These piezometers have been noted as being dry in all other readings. Piezometers P4, P5, and PM3 were reported to have water in them but there was less than 0.10 ft. difference between the bottom of the piezometer and the free water surface and it is assumed that this is most likely rain water, minor seepage or other accumulations of water not related to the phreatic water surface in the embankment. These piezometers have been reported as being dry or as having less than 0.10 ft. of water depth in all other previous readings. Piezometer P-O was not read on the day of this inspection.

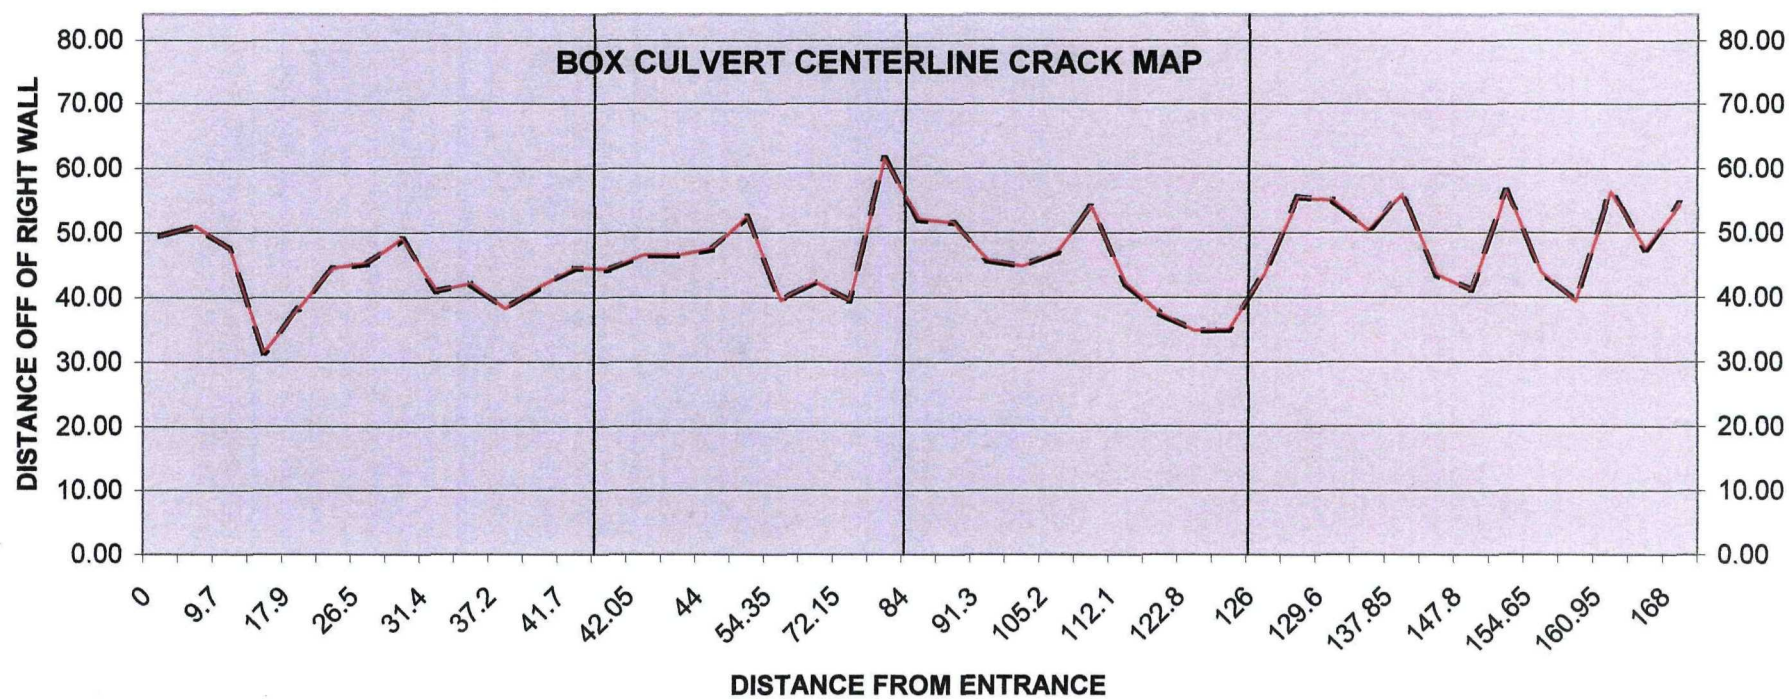
Kootentai Impoundment Dam Box Culvert Crack Map First Section

The inside of the box culvert was inspected from the entrance to the exit. The crack in the invert of the culvert that runs the full length of the culvert was noted as having no change from the spring inspection.

The invert crack runs down the centerline of the box culvert. In order to monitor the crack a baseline map needed to be developed that plotted the location, crack width and crack depth at each location. This project was completed during this site visit. The crack was mapped from the entrance to the outlet. A 300 ft. fiberglass tape with a ± 0.01 ft. accuracy was used to measure the distance from the inlet to a measurement point. A steel tape with a $1/16^{\text{th}}$ inch (0.005 ft.) accuracy was used to measure the distance from the right side wall of the box culvert to the center of the crack. A Starrett Dial Calipers with a 0.001 inch (0.0001 ft.) accuracy was used to measure the crack width at each measurement point.
